[Docket No. FAA-2006-25703; Directorate Identifier 2006-SW-20-AD; Amendment 39-14747; AD 2006-17-51]

Airworthiness Directives; Agusta S.p.A. Model AB139 Helicopters

2006-17-51 Agusta S.p.A.: Amendment 39-14747. Docket No. FAA-2006-25703; Directorate Identifier 2006-SW-20-AD.

Model AB139 helicopters, with tailpipe assembly left hand, part number (P/N) 3G7800L00131 and right hand, P/N 3G7800L00231, installed, certificated in any category.

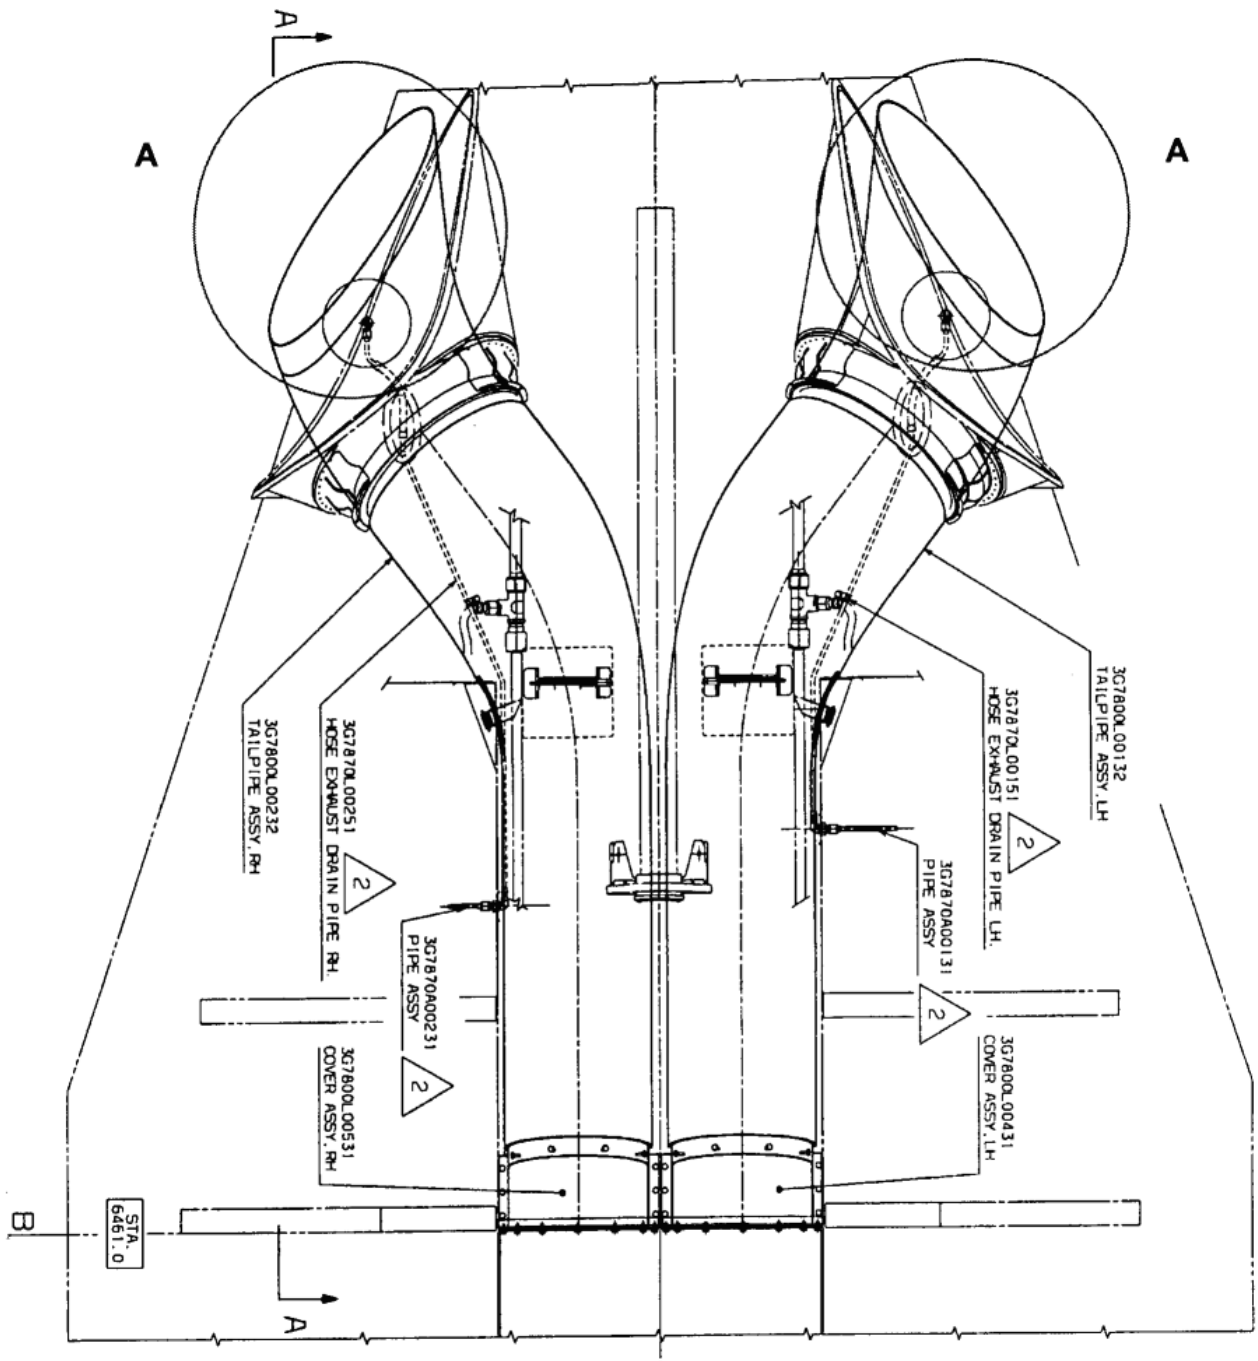
Figure 1

The European Aviation Safety Agency (EASA) notified us that an unsafe condition may exist on Agusta S.p.A. Model AB139 helicopters. EASA advises that the field has reported tailpipe assembly cracks. EASA also advises that this issue, if not corrected, could lead to overheating of the structure in the cowling area or separation of parts hence endangering the safety of helicopter flight.

(2) Inspect the structure surrounding each tailpipe assembly for overheating. If you find areas of overheating, inspect for heat damage to the surrounding structure. Inspect for overheating in the area of each tailpipe assembly outside the cowl. Inspect the internal part of each tailpipe assembly in the areas depicted in Areas A, Figure 1, of this AD.

(i) Clean the end of each tailpipe assembly with a cloth. While applying slight pressure on it, inspect for a crack using a flashlight.

(ii) Inspect each tailpipe assembly toward the centerline of the helicopter for a crack using a flashlight.

(iii) Inspect each tailpipe assembly toward the outboard side of the helicopter for a crack using a mirror and a flashlight.

(3) If you find a crack, before further flight, replace the tailpipe assembly with an airworthy tailpipe assembly.
